DEPARTMENT OF TRANSPORTATION**DIVISION OF ENGINEERING SERVICES**

Quality Assurance and Source Inspection

Contract #: 04-0120F4Cty: SF/ALA Rte: 80 PM: 13.2/13.9File #: 13.28**WELDING INSPECTION REPORT****Resident Engineer:**Pursell, Gary**Address:** 333 Burma Road**City:** Oakland, CA 94607**Report No:** WIR-007106**Date Inspected:** 05-Jun-2009**Project Name:** SAS Superstructure**OSM Arrival Time:** 700**Prime Contractor:** American Bridge/Fluor Enterprises, a JV**OSM Departure Time:** 1530**Contractor:** Oregon Iron Works Clackamas, Or.**Location:** Clackamas, OR**CWI Name:** Mike Gregson, Rob Walters**CWI Present:** Yes No**Inspected CWI report:** Yes No N/A**Rod Oven in Use:** Yes No N/A**Electrode to specification:** Yes No N/A**Weld Procedures Followed:** Yes No N/A**Qualified Welders:** Yes No N/A**Verified Joint Fit-up:** Yes No N/A**Approved Drawings:** Yes No N/A**Approved WPS:** Yes No N/A**Delayed / Cancelled:** Yes No N/A**Bridge No:** 34-0006**Component:** Hinge K Pipe Beams**Summary of Items Observed:**

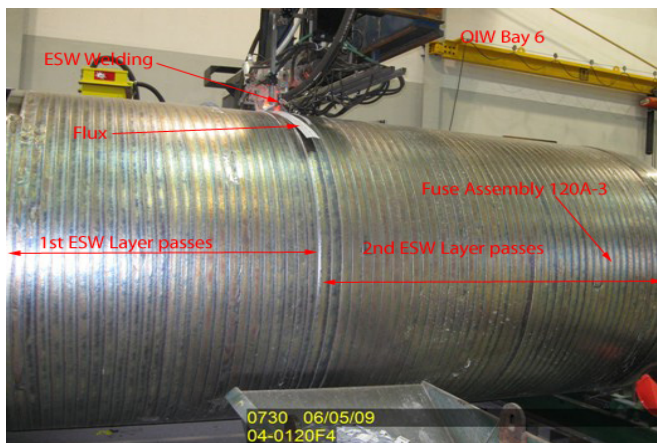
Hinge-K Pipe Beam Fuse Assembly 120A-3: 6/5/09

QA Inspector noticed that the stainless steel overlay welding was in-process, on this fuse assembly 120A-3. QA Inspector witnessed welder #F17, Mr. Igor Frolov, performing electro slag welding (ESW) in the flat position, utilizing Soudokay brand Soudotape 316L stainless steel consumable strip. QA Inspector noted the first ESW

welding passes were complete, utilizing Soudokay brand Soudotape 309L stainless steel consumable strip and the second layer passes were in-process, approximately 50% complete. QA Inspector noticed QC Inspector's Mike Gregson and Rob Walters were present, to verify in-process welding parameters (amps/volts) and monitor in-process continuous pre-heat temperatures. QA Inspector spoke with QC Inspector Rob Walters and Mr. Rob Walters explained that welding amps were recorded as 1300 amps/24 volts, with and a pre-heat temperature of approximately 225 Fahrenheit. QA Inspector verified Mr. Craig Jacobson was currently qualified for this welding process/position and randomly recorded pre-heat temperatures of approximately 250 Fahrenheit. QA Inspector noted that Mr. Craig Jacobson appeared to be in compliance with the applicable approved welding procedure specification (WPS 7003). See picture below of fuse assemble 120A-3.

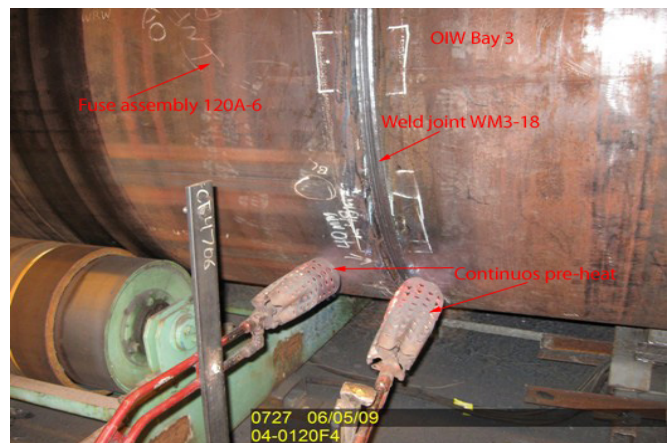
Hinge-K Pipe Beam Fuse Assembly 120A-6: 6/5/09

QA Inspector randomly witnessed welder #S53, Mr. Jerry Shepherd, perform submerged arc welding (SAW) on CJP (AWS D1.5 B-U3c-S), half fuse pipe assembly, (piece mark identified as a124-1), to half fuse pipe assembly, (piece mark identified as a124-9), in the flat position (1G). QA Inspector spoke with QC Inspector Mike Gregson and Mr. Gregson explained that the OIW welder #S53, was performing submerged arc welding in accordance with the OIW approved welding procedure specification (WPS 4020).

QA Inspector verified Mr. Jerry Shepherd was currently qualified for this welding process/position and performed a random pre-heat check and recorded temperatures of approximately 350 degrees Fahrenheit. QA Inspector also recorded random, in-process welding parameters (amps/volts) of 400 amps and 25 volts, which is in compliance with the OIW welding procedure specification (WPS 4020). See 120A-6 picture below.
